PROJECT: Midnite Mine Remediation

REPORT NO: 2019-022

This weekly report provides a summary of Midnite Mine Site (Site) remediation action (RA) construction activities, quality assurance (CQA), quality control (CQC) and engineering activities for the period August 23 – August 29, 2019. The Site activities discussed in this weekly report include, but are not limited to: Site Health, Safety, and Security; Community Liaison, Project Meetings, Regulatory Oversight, Site Visitors; Site Mobilization; RA Activities; Project Documentation; and Site Inspections.

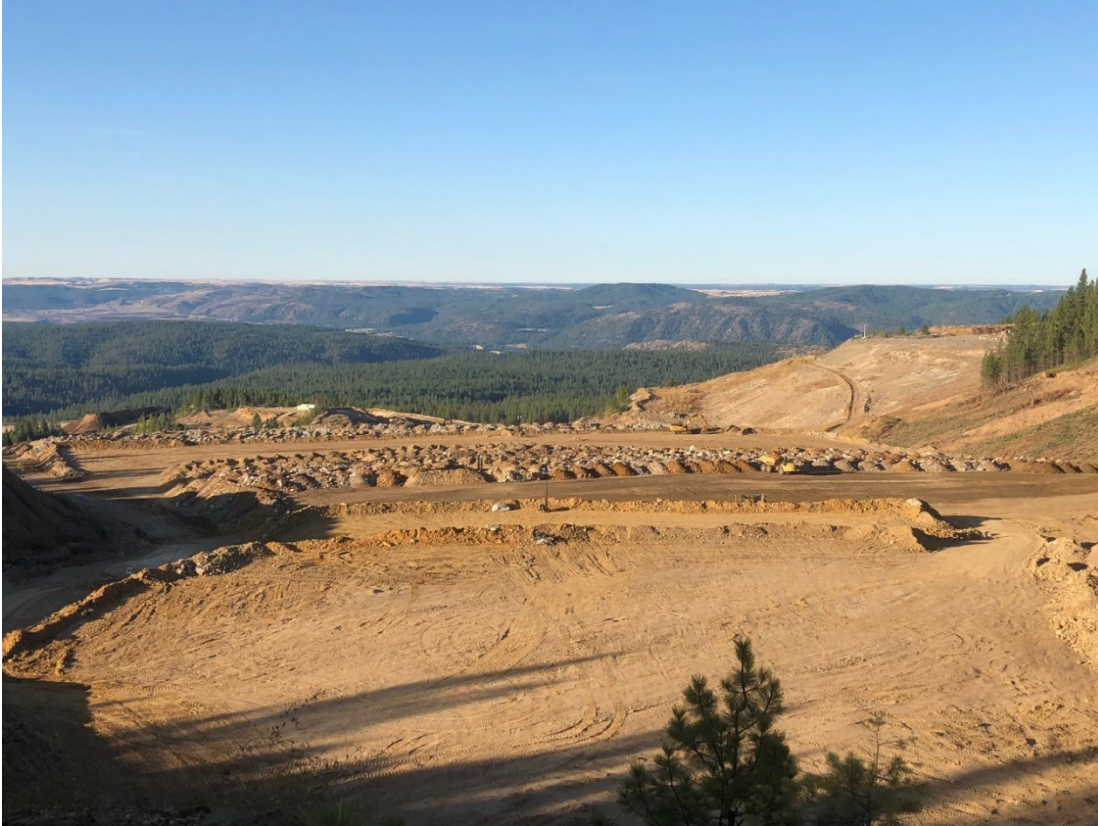
Figure 1 – Pit 4 overview, looking south.

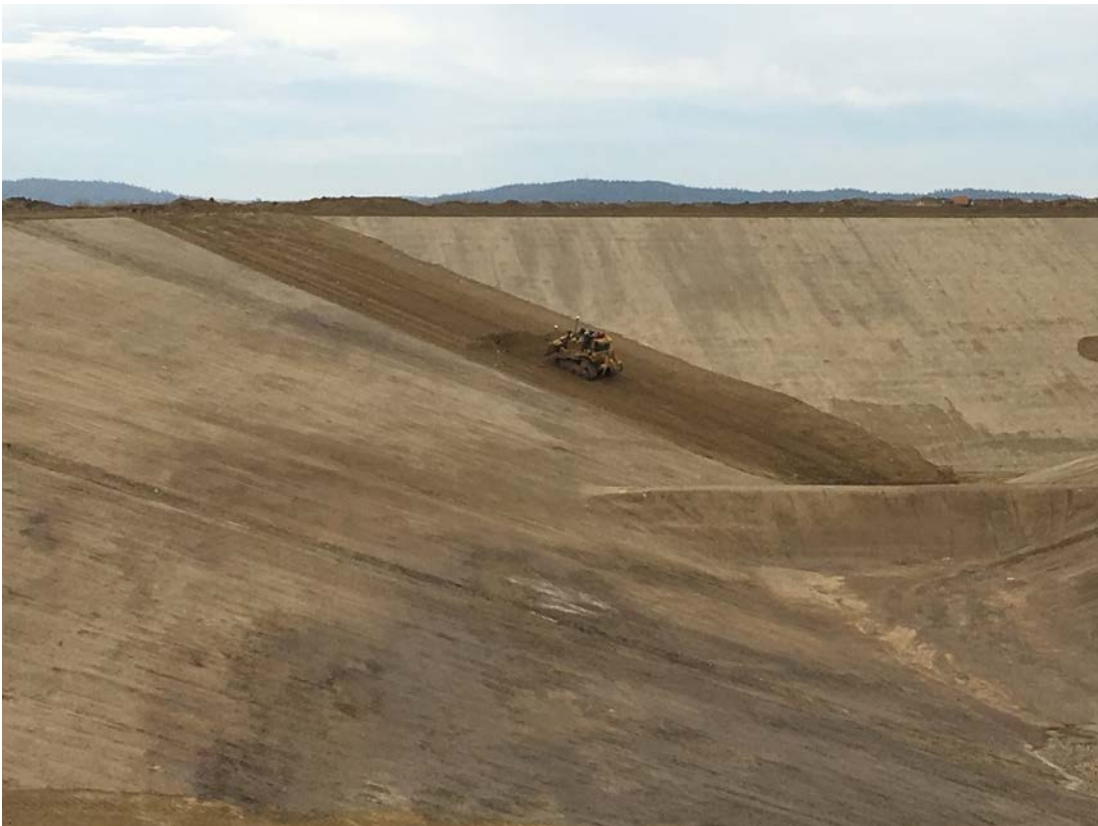
Figure 2 – CAT D6 dozer cleaning up / grading South Pond slope, looking west.

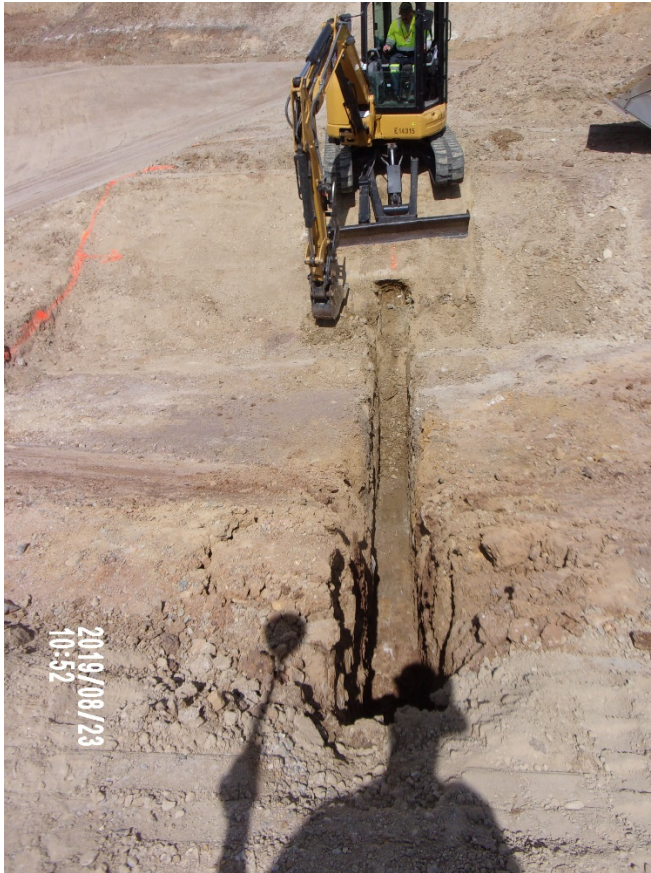
Figure 3 – South Pond Spillway cutoff wall excavation, looking north.

- Continued constructing the High Road along the north side of Protore Stockpile 4 and west of Pit 3 in the vicinity of the former light vehicle road.
- Excavated the cutoff walls for the South Pond Spillway

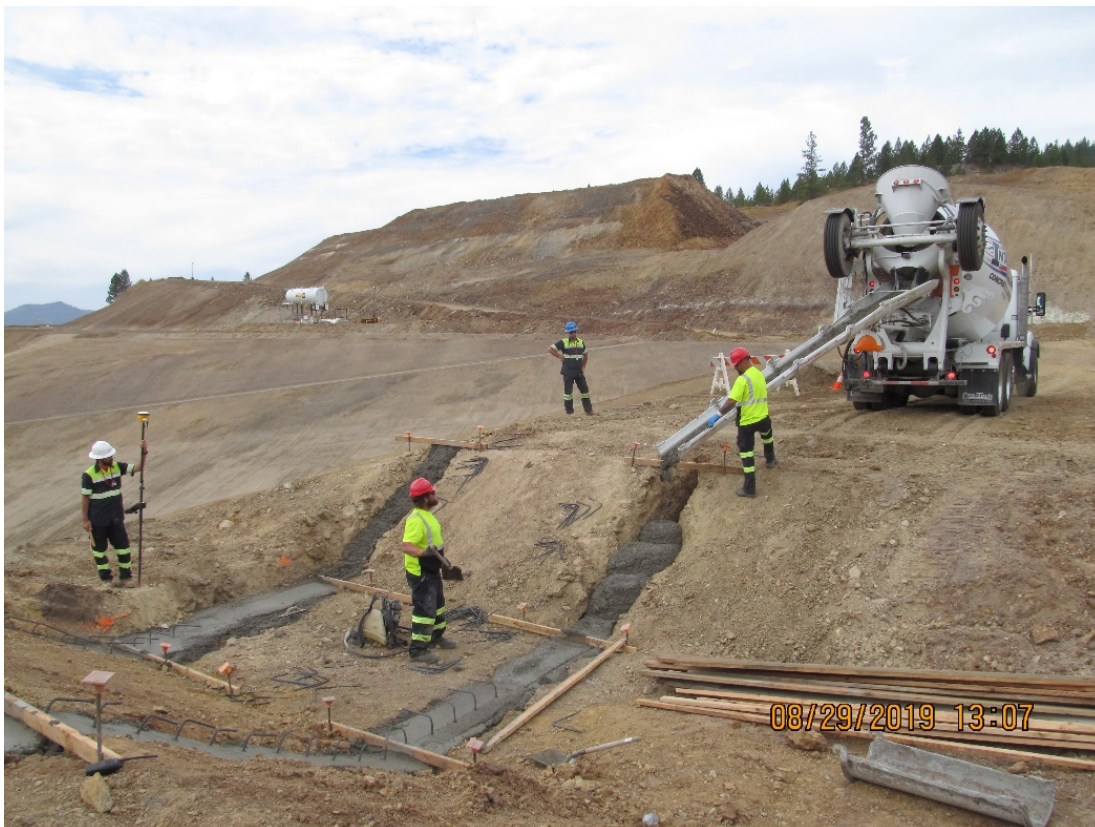
Figure 4 – Concrete Pour for the South Pond Spillway Cut-Off Walls.

- Wm. Winkler poured the concrete cutoff walls for the South Pond Spillway and began forming and placing rebar for the Western States maintenance area concrete slab.
